BODY INTERIOR

BODY INTERIOR RODIUS 2016.09

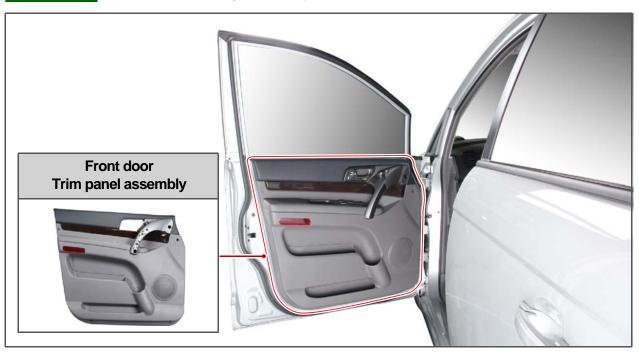
7115-01 FRONT DOOR TRIM PANEL ASSEMBLY

1. Prize off the front door inside handle bezel from the bottom using the remover.

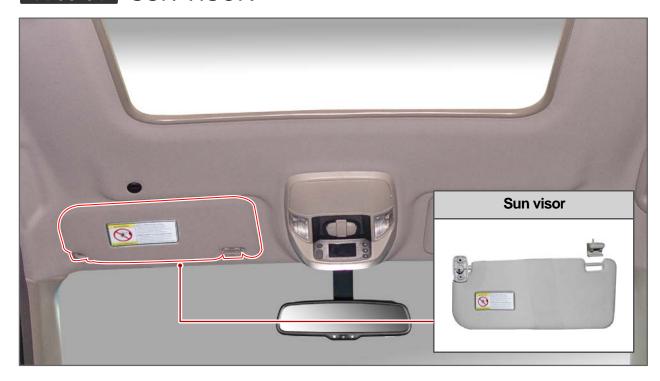
7700-01 SUN VISOR

1. Unscrew the 2 sun visor mounting screws.
